# UTILISING RECYCLED MATERIAL STABILISED WITH BITUMEN TO REHABILITATE A MAJOR HIGHWAY WITHIN STRINGENT TIME CONSTRAINTS

**Abstract**— The Ayrton Senna Highway feeding into São Paulo City from the north-east ranks as one of the most heavily-trafficked links in Brazil's road network. This highway was originally constructed in the late 1970s and now carries more than 200 000 vehicles per day ( $\pm 15\%$  heavy vehicles). A concession agreement with the State Highway Authority was signed in 2009 transferring maintenance responsibilities to EcoRodovias, a consortium of large construction companies.

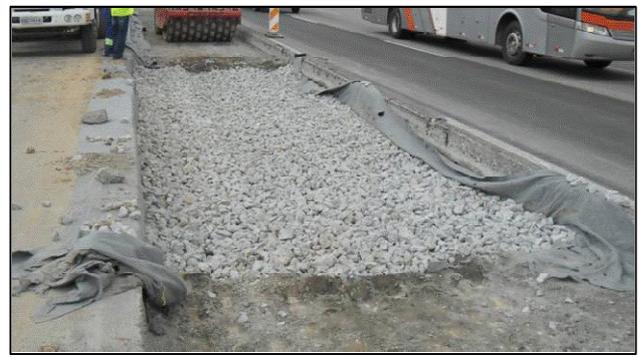
Fig 9. Undercut backfilled with coarse crushed stone

An excavator was immediately brought in and saturated material removed to a depth of approximately 500mm. The trencher followed the excavator and the outlet drain installed within an hour. The geofabric liner was then placed and the hole backfilled with coarse crushed stone (see Figure 9). The two BSM layers were then constructed followed by the thin asphalt surfacing and the section was opened to traffic before nightfall when the full width of carriageway had to be opened to traffic.
