THE LONG-TERM BEHAVIOUR OF BITUMEN STABILISED MATERIALS (BSMs)

Dave Collings Kim Jenkins

Abstract

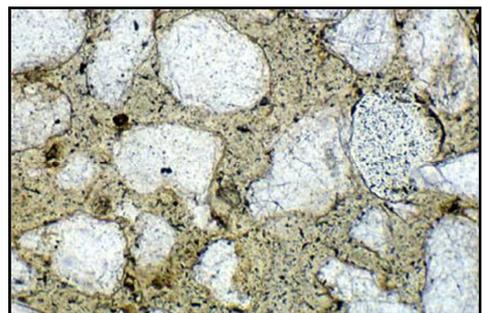
Figure 1 has been used in many publications to explain the nature of a BSM. This picture shows a compacted slice of aeolian dune sand treated with 4% foamed bitumen, magnified 40 times.

(The original picture was taken in 1994 using a slice prepared by KZN University's Geology Department). Since the dune sand is white and bitumen black, this picture clearly shows the bitumen is dispersed throughout the matrix of the dune sand as tiny splinters. The coarser particles (maximum size is 0.425mm) are not coated with bitumen. When such a material is compacted, the individual bitumen splinters are mechanically forced against their neighbouring particles and, being sticky in nature, the bitumen splinter adheres to its neighbour, setting up an isolated bond. With the bitumen dispersed as millions of such splinters, the result is millions of localised bonds that are isolated; hence the term "non-continuously bound" material.

Figure 1. Dispersed bitumen splinters

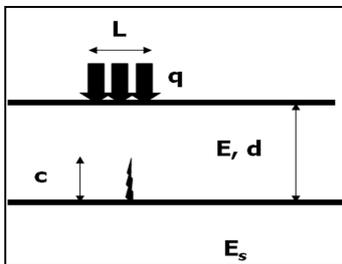
It is understandable that Paris’ Law can be applied to asphalt, which incorporates bitumen that is distributed in a continuum and the asphalt layer can be treated as a beam since it is a continuously bound material. Besides other factors, the crack intensity factor is dependent on the ratio of crack length to beam thickness, c/d shown in Figure 2.

Figure 2. Beam approach to crack-growth analysis

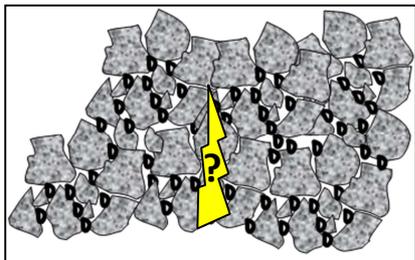
Unlike asphalt, BSMs do not have a continuum of bitumen and are seldom homogeneous, especially when recycled material is stabilised. This is shown conceptually in Figure 3. Discrete distribution of bitumen splinters in BSM-foam does not allow classical fatigue and fracture

Figure 3. Non-continuous bound BSM-foam

mechanics to apply. If shear deformation between individual particles ruptures a “spot weld” of bitumen, there is no continuity of bound material that will allow a crack to develop, so c/d becomes meaningless. Stated differently, there is neither opportunity for a crack “head” nor stress intensity at the tip to develop. A broken spot weld will result in particles re-orientating (micro-shearing), resulting in permanent deformation, as with granular material. Rupturing of spot welds can influence the effective stiffness of the layer, as discussed later.

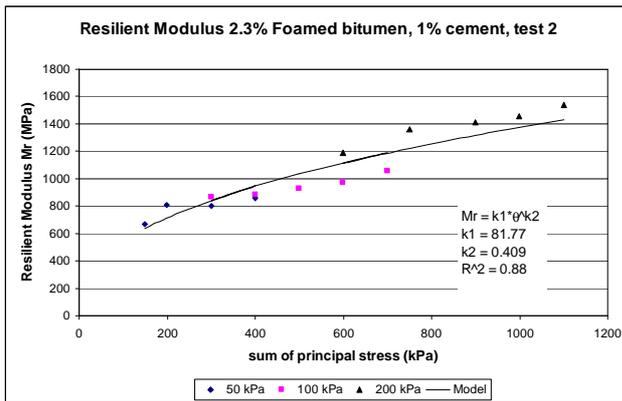
Figure 4. Dynamic triaxial tests on BSM-foam (Jenkins *et al*, 2002)

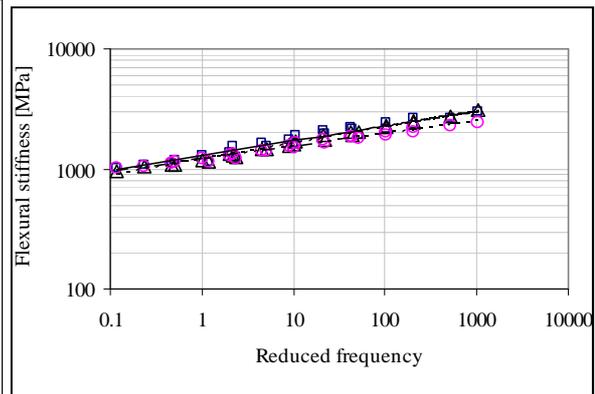
Figure 5. Master curves of BSM-emulsion and BSM-foam (Mathaniya *et al*, 2006)

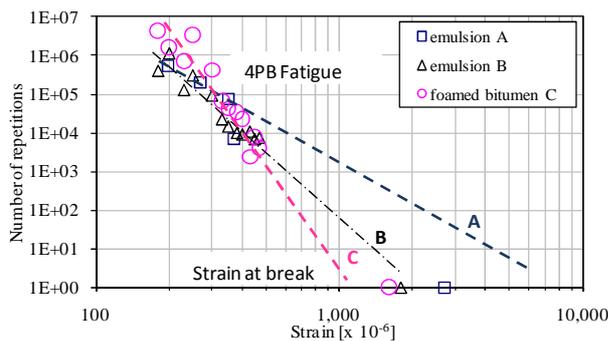
Figure 6. Fatigue versus Strain-at-break ϵ_b for BSMs with Crushed Aggregate including 25% RAP, three different bitumen stabilising agents and 0% Cement

Figures 6 to 8 make it abundantly clear that strain-at-break does not provide a reliable correlation with the fatigue relations that have been tested. Not only does the influence of the particular bitumen stabilising agent need to be considered, but also the non-linearity of the log strain versus log load repetitions relationship. Linear elastic behavioural modelling will not suffice due to plastic behavioural influences, and strain-at-break can therefore not provide a reliable performance indicator (which should be expected since BSMs are visco-elasto-plastic materials).

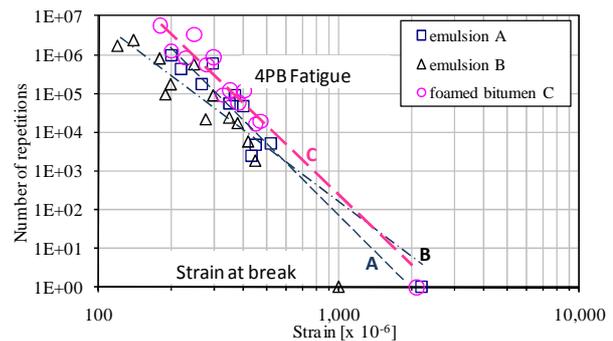
Figure 7. Fatigue versus Strain-at-break ϵ_b for BSMs with Crushed Aggregate including 25% RAP, three different bitumen stabilising agents and 1% Cement

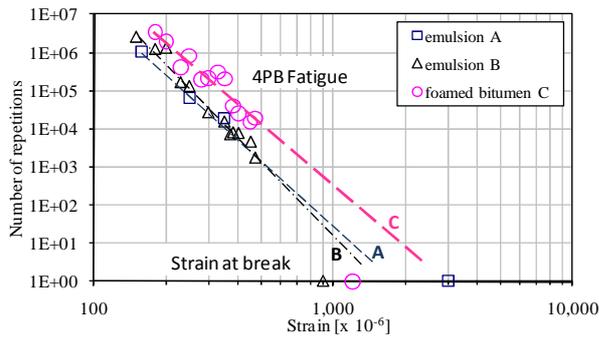
Figure 8. Fatigue versus Strain-at-break ϵ_b for BSMs with Crushed Aggregate including 75% RAP, three different bitumen stabilising agents and 0% Cement

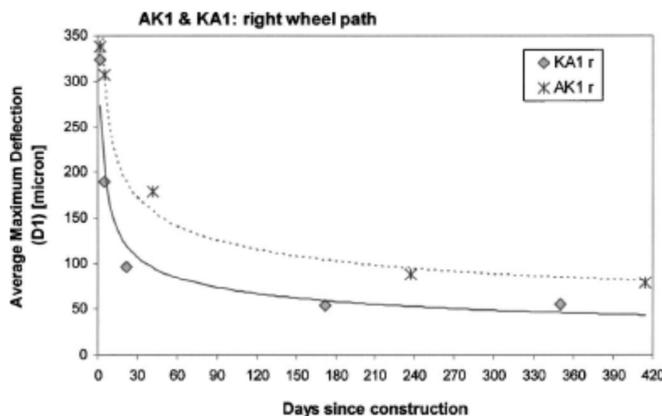
Figure 9. Change in FWD Maximum Deflection with time (Loizos *et al.*, 2007)

maximum deflection measured using the FWD is plotted in Figure 9 for the slow lane on both carriageways. The new layers in the pavement structure included only BSM-foam and HMA, so the stiffening of the pavement structure could only have emanated from the BSM layer. The FWD data was analysed further using deflection bowl back-analyses to determine the relationship in Figure 10 (Loizos *et al.*, 2007). The absolute values of BSM-foam stiffness are high, which could be a product of the in situ materials, but the trends of increase in stiffness are undeniable.

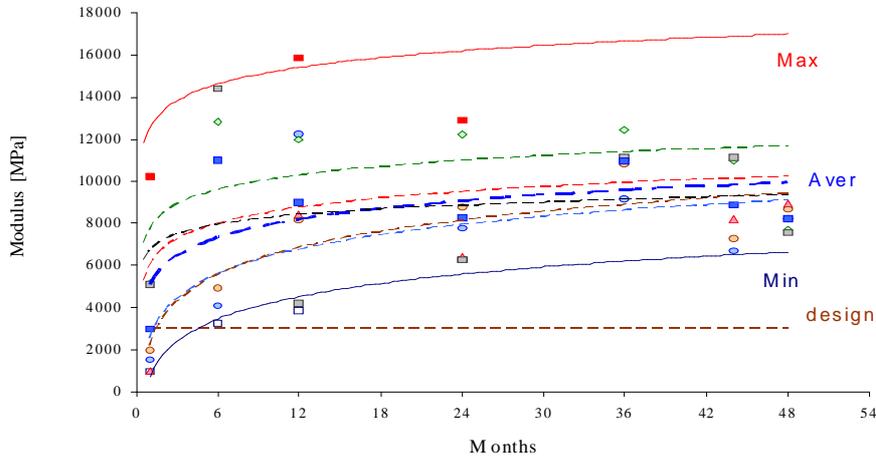
During the period of the deflection measurements, the pavement was exposed to some 60,000 vehicles per day (20% heavy vehicles with a legal axle load of 130 kN). The important feature of these analyses is the asymptotic relationship between the back-calculated modulus of the BSM-foam layer with time; the BSM-foam layer continued to gain stiffness.

Figure 10. Change in effective modulus of BSM-foam with time (after Loizos *et al.*, 2007)

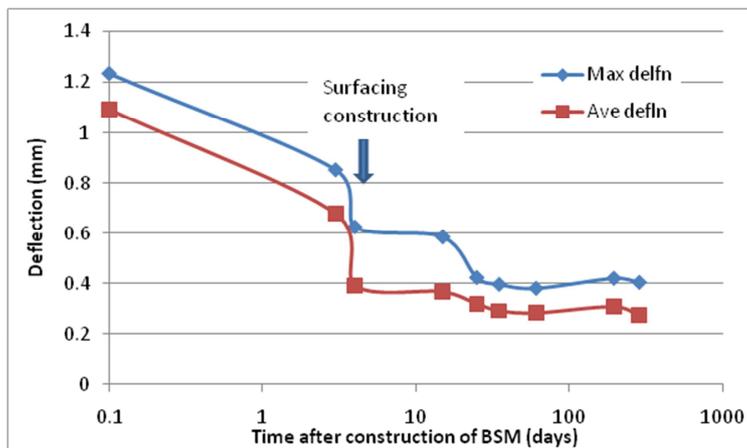
An analysis of pavement behaviour over time was carried out on the Jingshen Highway in China. This pavement was rehabilitated in 2005 by milling off 200mm existing asphalt and removing to temporary stockpile prior to recycling in situ 200mm of subbase comprised of cemented stabilised crushed stone material (addition of 2.3% foamed bitumen and 1% cement). A 150mm layer of pre-screened RA material treated in plant with 2% foamed bitumen and 1% cement was then paved as a new base layer, overlain with 50mm of MHA surfacing before opening to traffic. A Benkelman Beam was used by the Research Institute of Highways to measure the deflections up to one year after construction, as shown in Figure 11.

Figure 11. Jingshen Highway, Benkelman Beam deflections with time after construction

A significant reduction in the maximum and average deflections measured with the Benkelman Beam is apparent. The deflection reduction and hence increase in the Modulus of the BSM is

almost asymptotic, showing the majority of the change occurring during the first month and reducing exponentially with time. Throughout the entire year the pavement was exposed to extreme traffic loading (this particular highway is well known for overloading with loads in excess of double the legal axle load limit of 10 tons recorded). In spite of such abuse, the BSM layer continued to increase in stiffness during the first year.

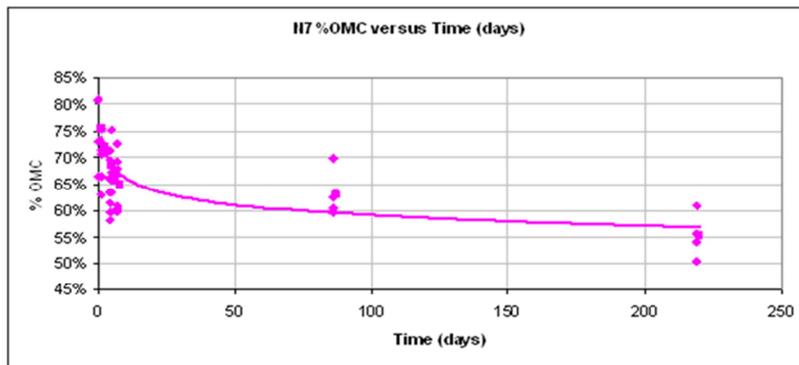
This example concerns the behaviour of a section of the N7 highway near Cape Town, part of which was rehabilitated by recycling with BSM-foam (2.3% bitumen and 1% cement) on the Southbound Carriageway in 2002. The Northbound Carriageway was rehabilitated by recycling with BSM-emulsion in 2007 (2% residual bitumen and 1% cement). Both carriageways were recycled in situ and stabilised to a depth of 250mm. Physical moisture measurements of the BSM-emulsion base layer were tested in the laboratory, supplemented by moisture button monitoring in the layer (Moloto, 2010). In addition, Portable Seismic Pavement Analyser (PSPA) measurements were taken on the BSM base with time in order to evaluate the change in modulus of the base with time. Figures 12 and 13 show that the modulus is inversely proportional to the moisture content of the BSM-emulsion layer, a phenomenon known as “curing”. For the seven months evaluation period, the rate of change in both moisture content and modulus is exponential as a function of time. The change in moisture content of the BSM-emulsion concurs with the trends found for BSM-foam curing rates (Malubila, 2005).

Figure 12. Moisture content in BSM-emulsion base from oven drying (Malubila, 2005)

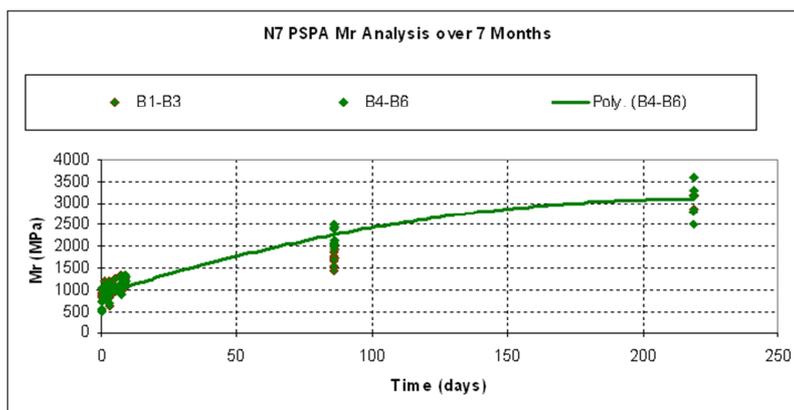
Figure 13. Modulus of BSM-emulsion base measured with PSPA (Malubila, 2005)

Focusing on the first year after construction, the above three examples of in situ measurements of BSM bases all show an increase in effective stiffness. This is consistent with the trends found in the laboratory during curing of BSMs. The following insights are obtained from these findings:
